# Sustainable rehabilitation strategy of water well gallery on Elbe river bank

This case study documents how a change of a rehabilitation method helped to secure the water supply of a chemical plant, and lengthened the operation time of a water well gallery due to concerns regarding the physical stability of the wells as the majority of them are older than 80 years. The outcome of the revision of methods proved most beneficial to the well owner due to both the unexpected high increase of well yields and to the remarkable financial advantages.

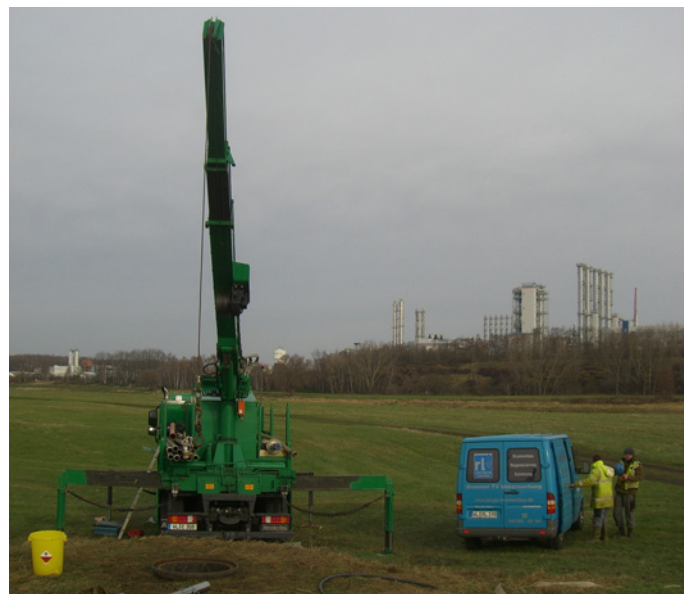
The state-of-the-art technical equipment of the rehabilitation company selected for the job fulfilled all requirements even managing to avoid damaging the surrounding arable farm land. The 6 x 6 off-road truck was not only equipped with tractor tyres for marshy terrain, but also had the complete infrastructure integrated on the rack body including a 50 kVA generator (**Figure 1**).

Figure 1: Well site on the river bank. © Rudolf Lange Brunnenbau KG, 2013

Frames for rising mains and additional pipes, a number of pumps, the multi-chamber gravel washer, a screw compressor together with a covered mixing unit for the chemical agent also used for storing spare parts and well brushes, were all on board. A crane mounted in the rear of the truck enabled both a comfortable erection of the rehabilitation site, and a fast and efficient execution of each working step.

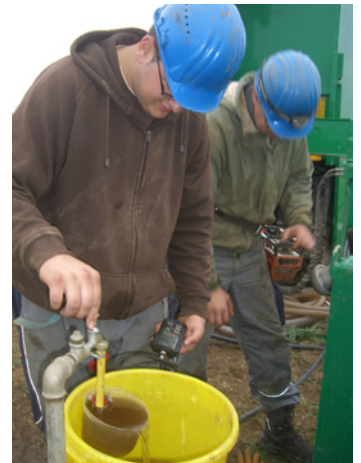
Water samples were taken every 15 minutes from the lower chamber of the gravel washer to monitor the chemical process by measuring specific electrical conductivity and the concentration of dissolved iron(II) during the reaction time of the agent (Figure 2). After 45 minutes the pumping of each treated section was continued as long as the conductivity and the iron(II) concentration had reached the zero values again.

**Figure 2:** Process control of hydraulic-chemical rehabilitation. © Rudolf Lange Brunnenbau KG, 2013

In a number of screen sections the concentration of dissolved iron(II) jumped up and remained high during the chemical reaction, and it was decided to repeat the treatment. Due to autocatalysis of iron it is of utmost importance to remove ferric iron oxide phases as thoroughly as possible, otherwise they can quickly precipitate and adhere to the surface of gravel grains again ( $r = k_1 \{Fe^{2+}\} (O_2)_{(aq)} \{H^+\}^{-2} + k_2 \{Fe^{(III)}\} \{Fe^{2+}\} (O_2) \{H^+\}^{-1}$ ). In the worst case this could mean that an incomplete rehabilitation accelerates natural well ageing instead of slowing it down.

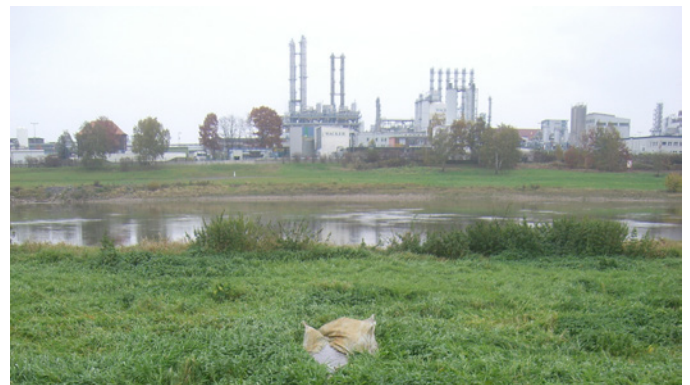
**Figure 4:** Discharge out of the well. © Rudolf Lange Brunnenbau, KG 2013

does not require any further treatment. In this case it was pumped on defined areas on the river bank in agreement with the local environmental authorities (Figure 4).

All reaction products originating from the reducing agent in contact with hydroxides of iron and manganese occur in groundwater itself and are classified as totally harmless. Soluble iron(II) and/or manganese(II) can be found in combination with sodium, hydrocarbonate and sulphite which is quickly transformed in sulphate exposed to free-air. Analogous to other rehabilitation agents the values of conductivity vary and the discharged water can be murky due to mechanically loosened particles such as sand and ochre.

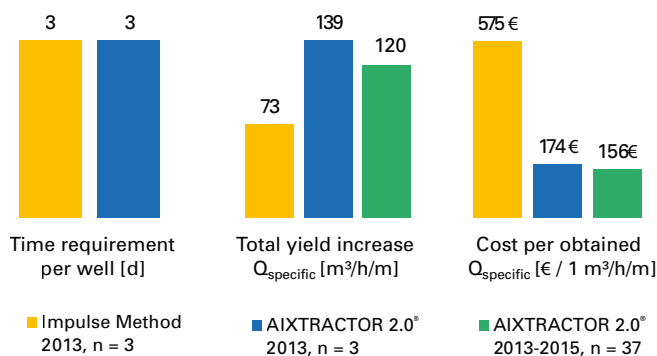
Figure 5: Evaluation of results AIXTRACTOR 2.0 & Multichamber system vs. Impulse method. © Wacker Chemie AG 2013, 2015

The extensive documentation on the part of the well owner not only confirmed that the time frame remained identical regardless of the rehabilitation method i.e. a high-performance gravel washer enabled both a hydraulic and a chemical treatment within the same period of time than traditional hydraulic rehabilitation only. The respective yield increase of the individual wells reassured the well owner that the revision of his rehabilitation strategy had been justified (Figure 5).

Furthermore, remarkable economic advantages resulting from the initial test rehabilitations in 2013 were revealed by a final cost analysis as the savings of more than 70% compared with the impulse method were unexpected high. The financial benefits of the rehabilitation work in 2015 surpassed those of the test series (Figure 5). The total rehabilitation cost per well by a combined hydraulic-chemical treatment was 9% lower than that of the test series in 2013. Furthermore, the overall savings of the total project reached theoretically 73 % if compared with the former rehabilitation procedure. Taking into account the number of 37 wells which are being operated on a permanent basis the savings can be considered quite substantial.

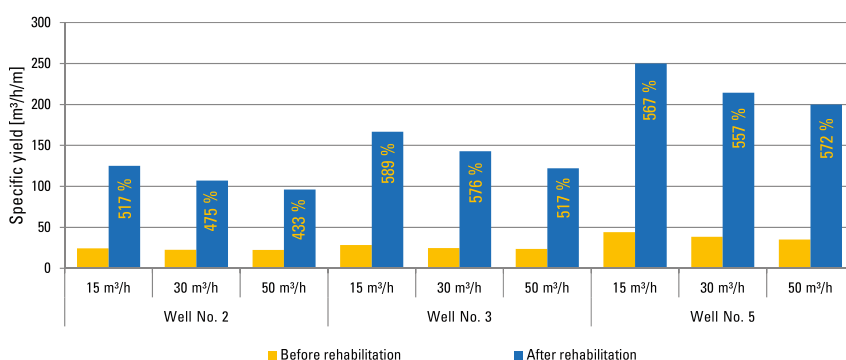
Figure 6: Excerpt of the evaluation of results AIXTRACTOR 2.0 & Multichamber system. © Wacker Chemie AG 2015

optimized combination of a high performance hydraulic device with a made-to-measure chemical agent. The respective increases of yield, from the average of 196 % up to 589 % (Figure 6), underlined the successful introduction of the new sustainable strategy providing for a larger volume of water and a longer operation time than ever before.
